TECHNICAL REPORT ARLCB-TR-85036

# STRUCTURE OF ELECTRODEPOSITED CHROMIUM ON GUN STEEL

M. H. KAMDAR

SEPTEMBER 1985

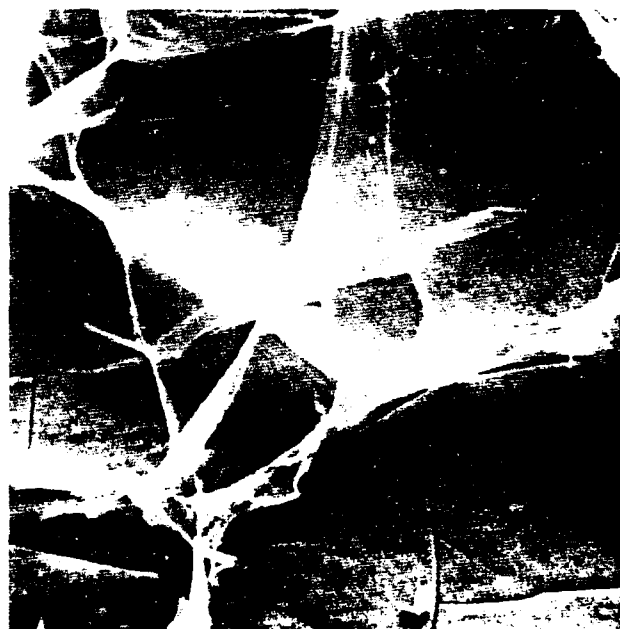
Figure 2

Scanning electron micrographs of chromium electrodeposited at 55°C and electropolished to reveal microcracks; cross section (a), and surface (b), (c), (d). Prolonged electropolishing enhances formation of amorphous film (c), (d).

The results of very deep electroetching of the chrome plate are shown in Figure 2. It may be seen that a thin film of what is presumed to be amorphous chromium oxide forms at the cracks (ref 13). This structure will be discussed further in a section dealing with the nature of microcracks in electro-deposited chromium.

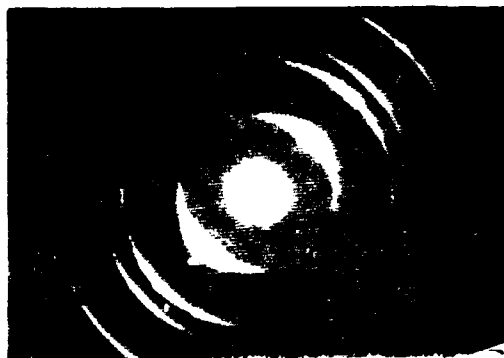
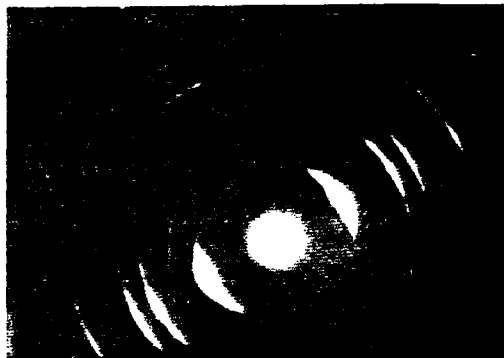
High voltage transmission electron micrographs of chromium electrodeposited at 55°C. Sample was tilted around an axis along the microcrack. Missing 200 reflection and discontinuous arcs are characteristic of a 110 fiber texture parallel to the film thickness direction.

When the specimen is tilted so that  $\langle 111 \rangle$  axes of the columnar grains are not parallel to the beam in the high-voltage microscope, a rather characteristic electron diffraction pattern appears, as illustrated in Figure 4. In this sequence of images and diffraction patterns, the foil was tilted about the axis of the crack running across the center of the field of view. The total range of tilting was 45 degrees, that is from +15 degrees to -30 degrees, as indicated on the figure. Gaps which occur in the diffraction rings and the characteristic striped pattern result from an oblique view of a fiber-textured specimen. Some micrographs of another tilt series are shown in the dark field in Figure 5. One of the striking features of the microcracks is that they are discontinuous and "ligaments" of metal connect some grains

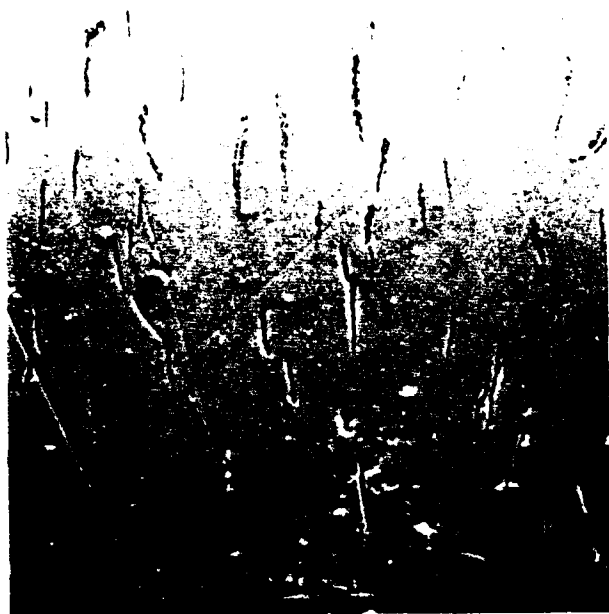
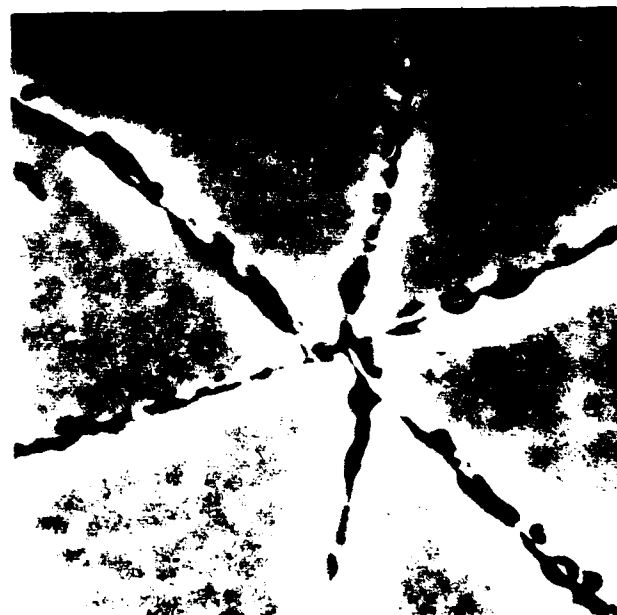
Scanning electron micrographs of chromium electrodeposited at 55°C and then annealed at 900°C for 1 hr to enlarge microcracks; both cross sections (a), (b), and surface sections (c), (d) were electropolished.

The crack pattern in the electroplated chromium becomes more pronounced after heating for one hour at 900°C and air cooling. Examples of cross and parallel sections are shown in Figure 6. It does not appear that the cracks are any more numerous than before but have become wider, presumably because of further contraction during annealing of the electrodeposit. The hardness decreased to 160 KHN as a result of the annealing treatment. This is a larger drop than might be expected from the grain size change, indicating that part of the high hardness results from the dense dislocation substructure.

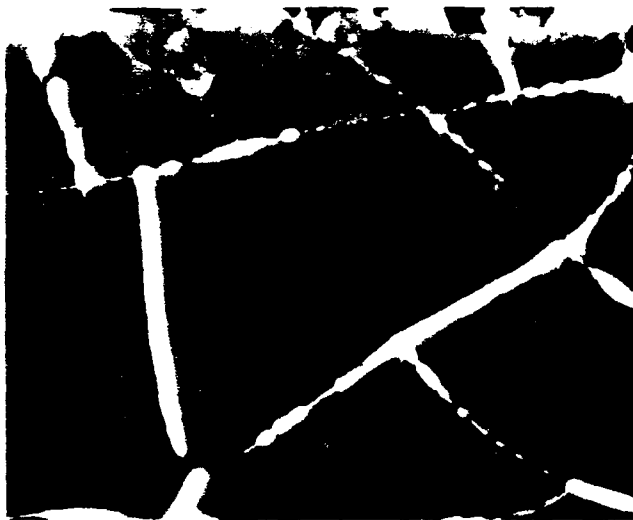
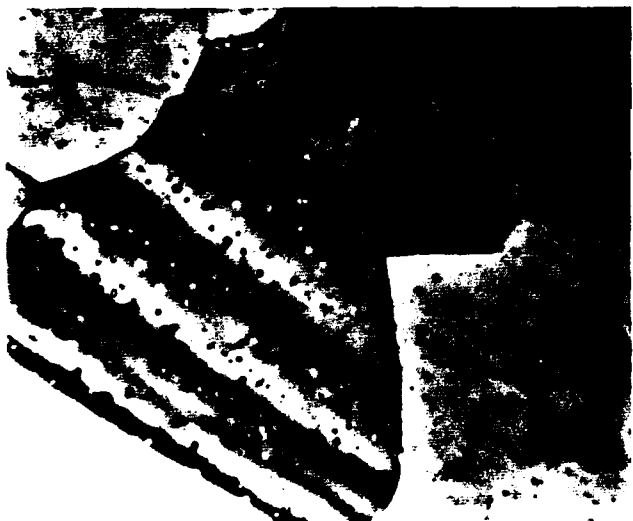
Figure 7

HVEM transmission micrographs showing chromium electro-deposited at 55°C and then annealed for 1 hr at 900°C resulting in crack coarsening (a), recrystallization (b), (c), and formation of fine precipitates or vacancy loops (d).

High voltage electron micrographs after annealing sample A for one hour at 900°C are shown in Figure 7. These show that although recrystallization has occurred, many of the ligaments along the cracks remain. It is more likely that they are chromium oxides formed from the codeposition of anhydrous chromium oxide in the grain boundary cavities during plating (ref 14).

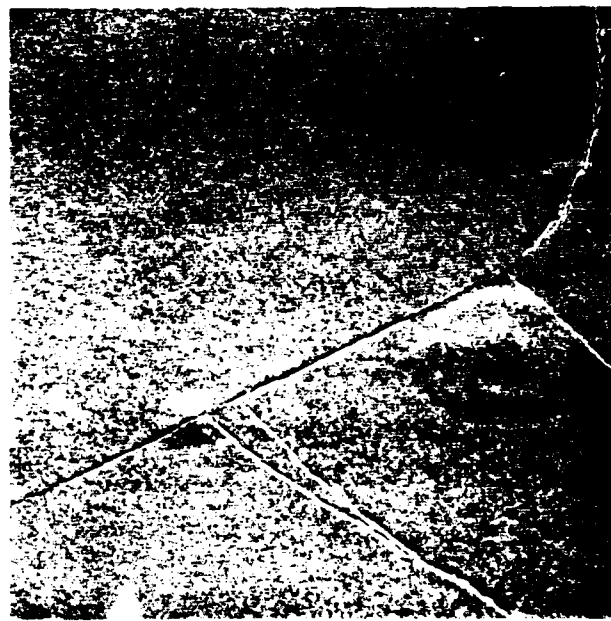
Scanning electron micrographs of chromium electrodeposited at 85°C showing coarse microcrack structure; cross sections (a), (b); surface sections (c), (d).

Sample B (chromium electrodeposited at 85°C) was examined in the manner described in the preceding section of this report. Optical micrographs of the cross and surface sections are shown in Figure 8, and scanning electron micrographs in Figure 9. It may be noted that the hardness of 650 KHN is about half that of sample A and the crack spacing is about ten times coarser. High voltage electron microscopy of ion-thin sections of the 85°C sample revealed a much coarser grain size and more random grain orientations, as illustrated in Figure 10.

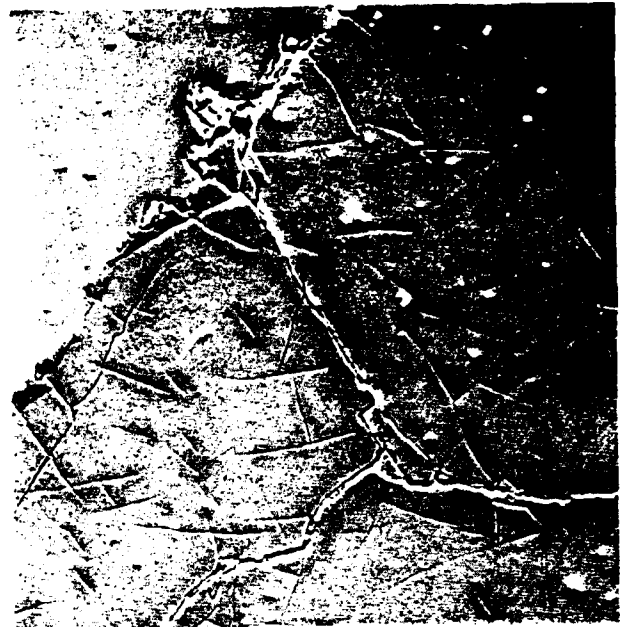
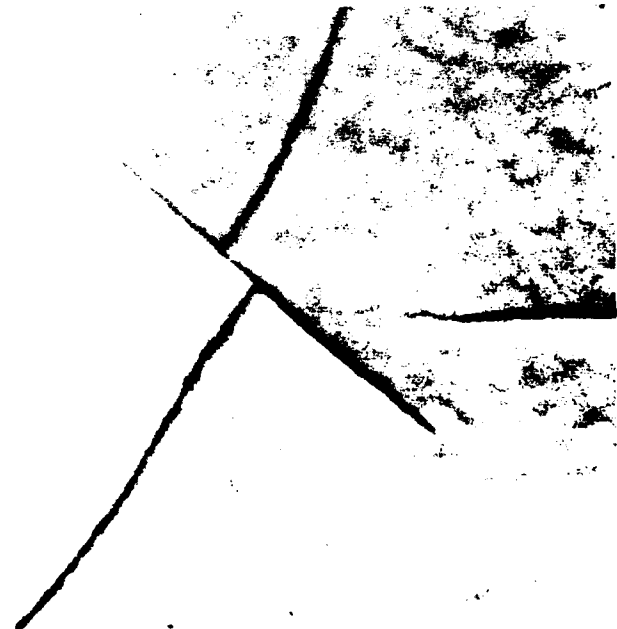
Scanning electron micrographs of mechanically polished cross section of chromium electroplate on a fired cannon.

Scanning and high voltage electron microscopy were also used to examine the chromium electroplate on a sample of fired cannon. Micrographs of the cross-section and surface are shown in Figures 12 and 13 after mechanical polishing, and in Figure 14 after electropolishing. The grain, dislocation, and crack structures in thin foils are illustrated in the high voltage micrographs in Figure 15. The cracks are wider and more complex after firing as compared with annealing at 870°C to 900°C for laboratory samples. During firing the surface is heated to >1100°C for a few milliseconds and is also exposed to explosive pressures. A more detailed study of the crack structures should be carried out.

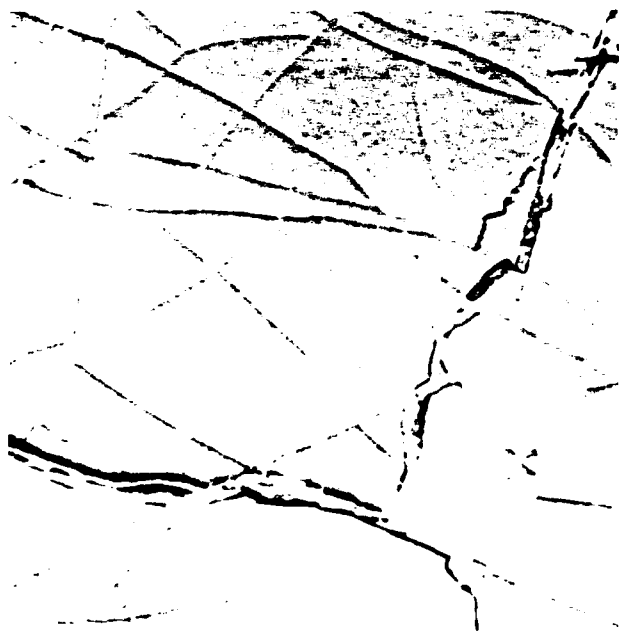
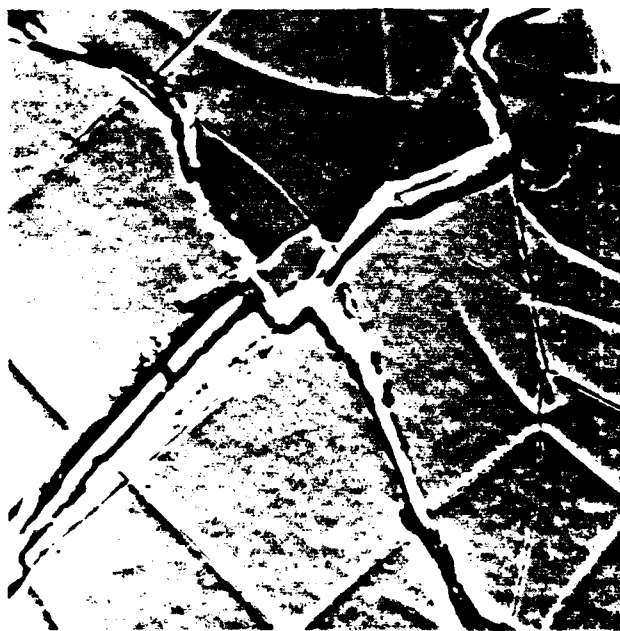
Scanning electron micrographs of electropolished surface  
of chromium on a fired cannon.
